RE: Site Inspection, American Gilsonite, Bonanza Mine Operations, M/047/010, Uintah County, Utah

Date of Inspection: October 29, 1997

Purpose of Inspection: To examine older gilsonite operations which were mined to the surface and closed by blasting

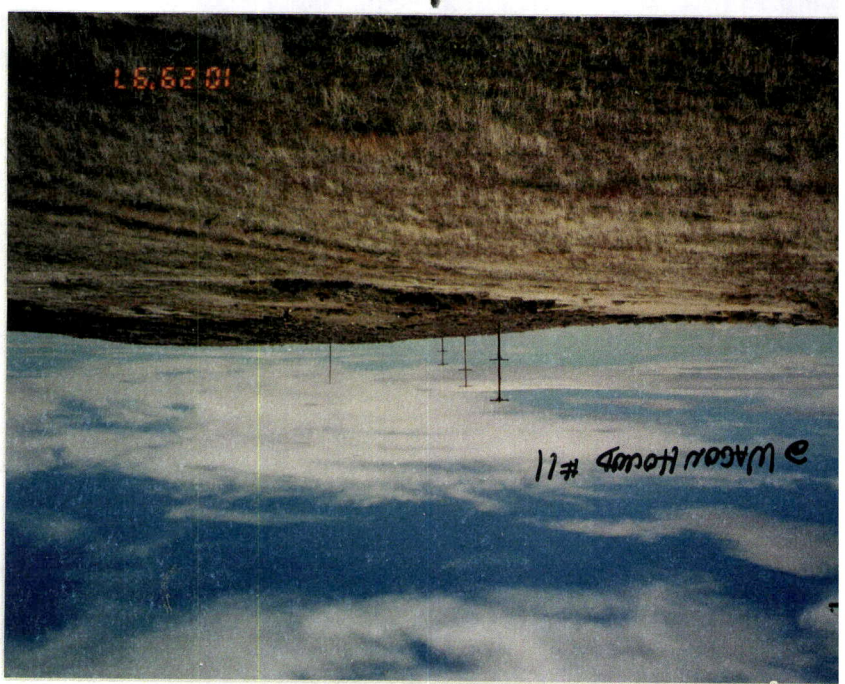
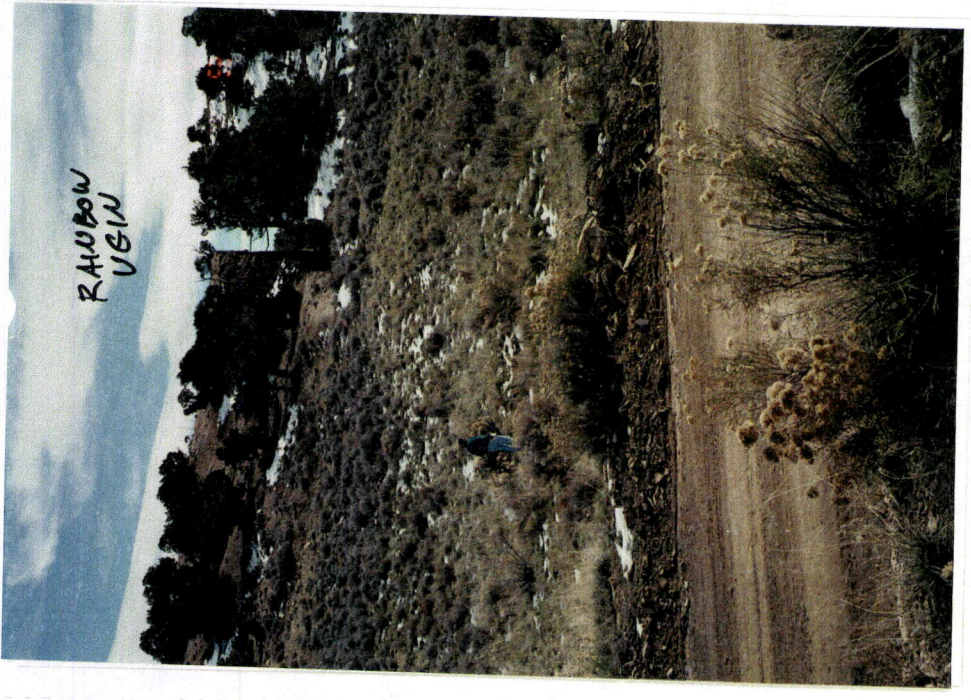
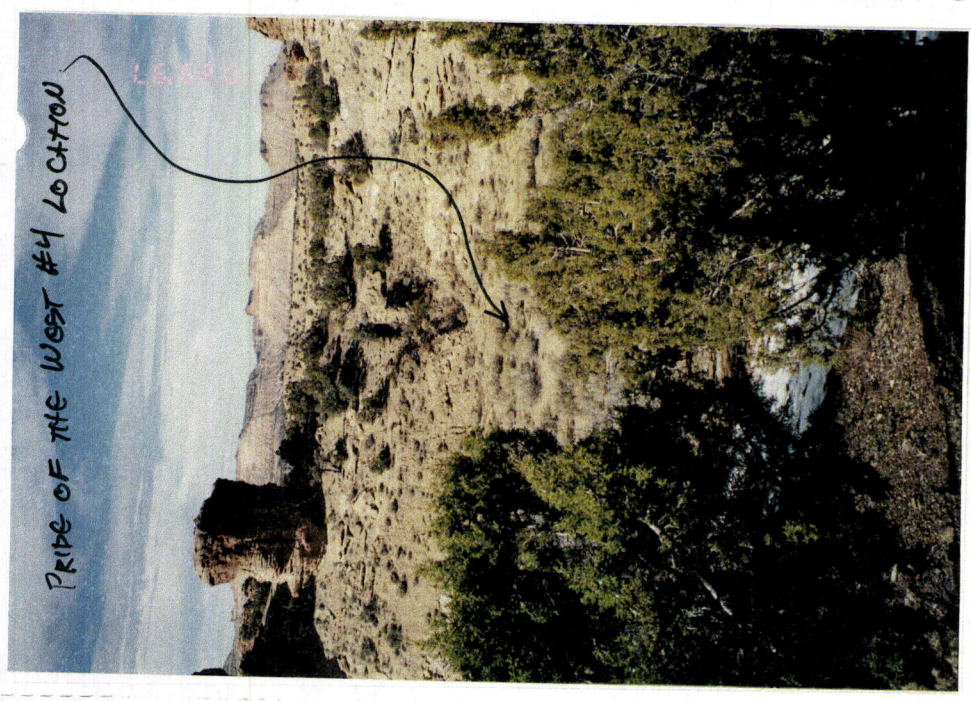
W/0NF/010

The next area visited was the Wagon Hound 11 site. This vein was mined about 500 feet deep and was open to the surface. The vein width ranged from 2 - 3 ½ feet. The length of excavation blasted was about 1,650 feet. Neldon believes they blasted this excavation using three separate segments. This vein was blasted around 1975 and then dozed and seeded. Neldon reported that the revegetation success was poor initially, so they reseeded the area. The disturbed area is much wider than the actual excavation, due to some seismic testing to figure out the best blasting pattern, amount of explosive charge, and how close the rounds should be to the vein. In one photograph of the area there is an open slot along the vein which ends at a large brush near the power line. Another photograph of this area shows the view to the southeast.

The next area visited was the Wagon Hound \_\_ site. At this site American Gilsonite has already mined the vein on the private portion using underground methods. They are proposing to mine the portion of the vein to the surface on federal land. Photographs were taken of the proposed open vein area. The escape-way for this open vein would be located in the photo at the pile of black drill cuttings near three people standing. These drill cuttings are from one of several holes which were drilled on the lease. This drilling was performed without authorization from the BLM; however, American Gilsonite does have this lease. The private portion of this vein is north (on the passenger side) of the BLM vehicle in the photograph. Photographs looking to the south over the proposed open vein mine area show an outcrop on the left. In this photo Stan Perkes and Neldon Kunz are standing in line with the vein. Another photo of this site includes a marker stake and some black cuttings on the ground at the location of one of the drill holes.
